US Army Corps  
of Engineers®  
Engineer Research and  
Development Center

*Opportune Landing Site Program*

## **Suitability Measurement and Analysis for El Centro Naval Air Facility OLS**

October 2008

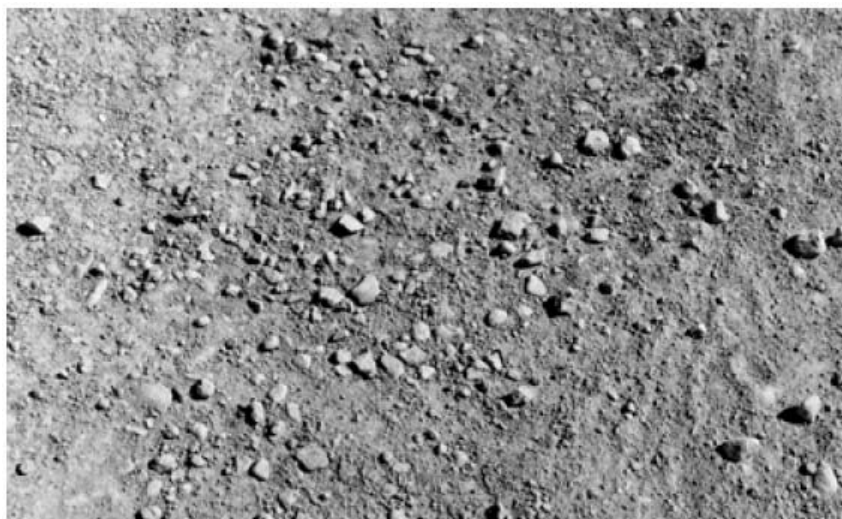
Loose Aggregate, Amber Severity

Figure 8. Picture from ETL 97-9 for severity rating of localized loose aggregate.

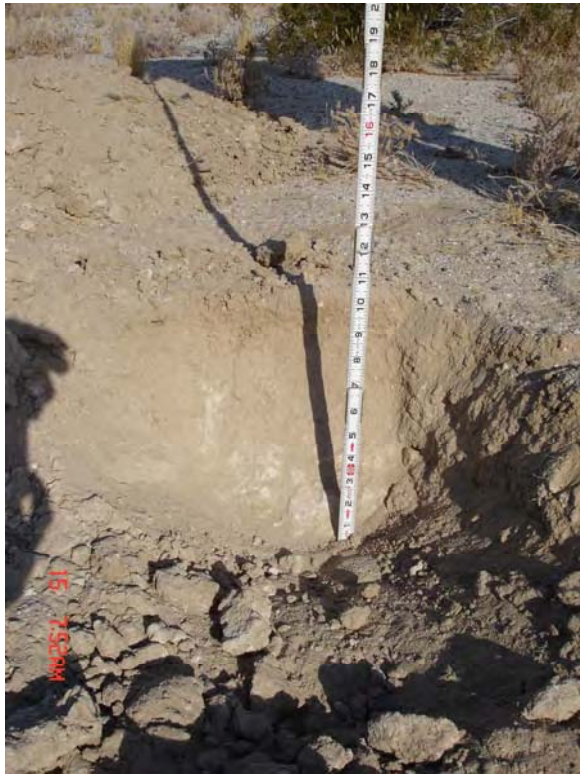
a. Cemented layer encountered showing soil clods.

A photo of the soil profile taken at 6+30 2S during the first visit is shown in Figure 19a. The bottom of the pit was 0.6 m (24 in.) deep. Samples were collected for the gradation analysis during the first and second visits. A set from the soil pit during IOP #1 and another set from drive cylinder samples also were taken during IOP #2. The results of the grain size analyses of all the soils collected at 6+30 2S are shown in Figure 19b. The entire soil profile is classified as Silty Sand (SM) with higher percent fines passing the number 200 sieve in the top 0.3 m (12 in.) than in bottom.

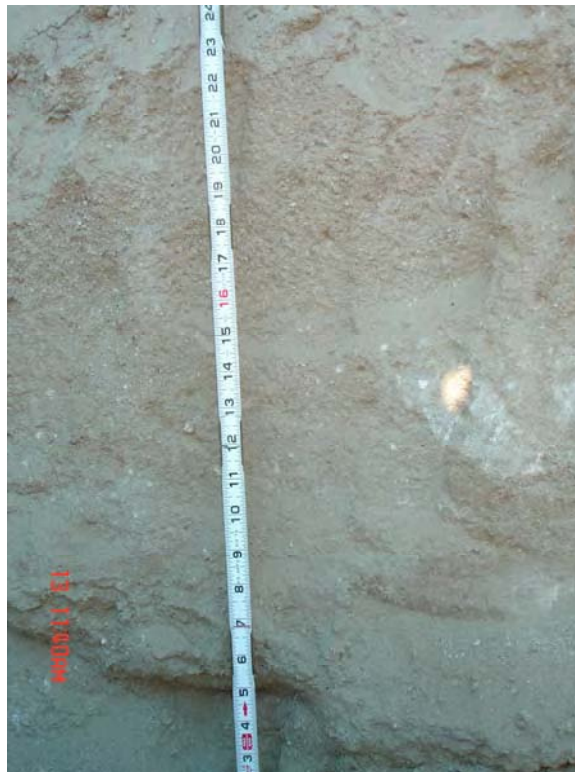
a. Pit at 9+80 2N was dug down to 0.81-m (32-in.) depth.

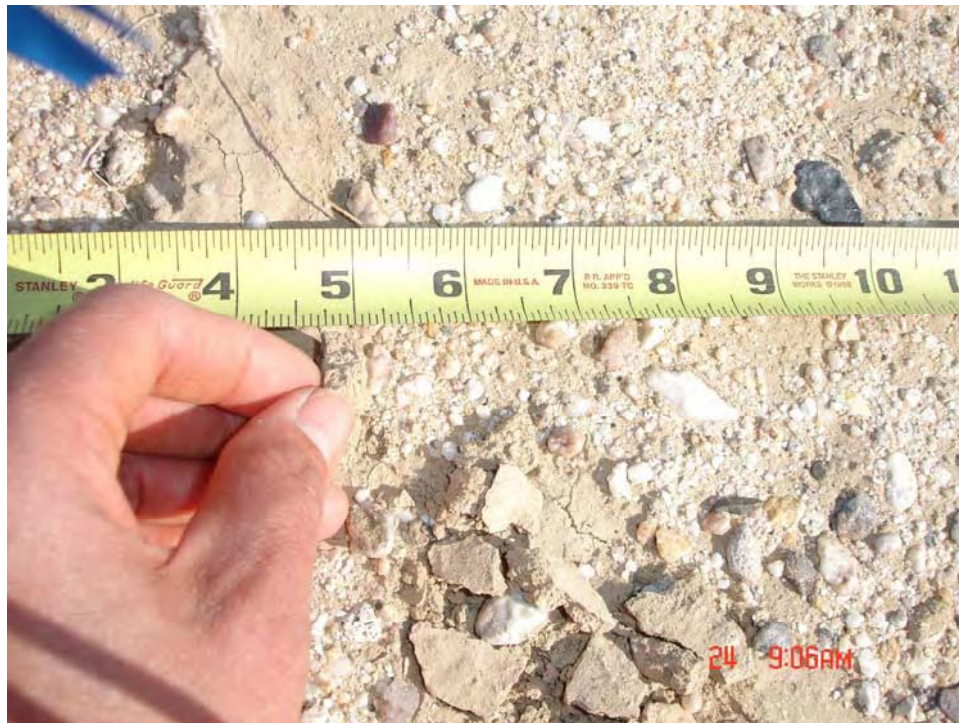
Figure 24. Cemented materials found on the surface of RAS.

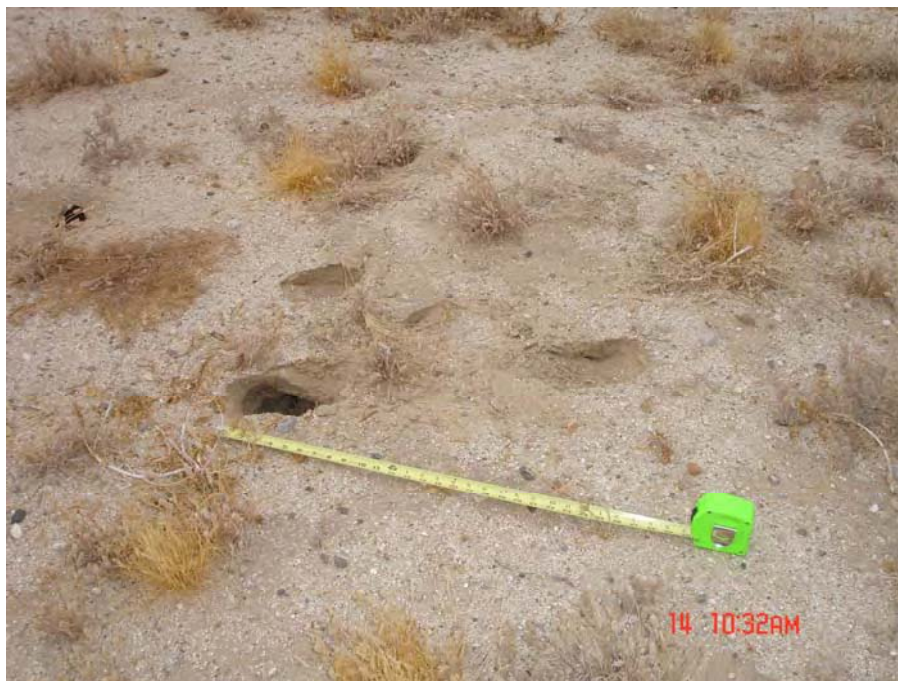
b. Soil and animal burrow.

Figure 26. Surface features such as mounds, animal burrows, and gravels were observed on the RAS at El Centro.

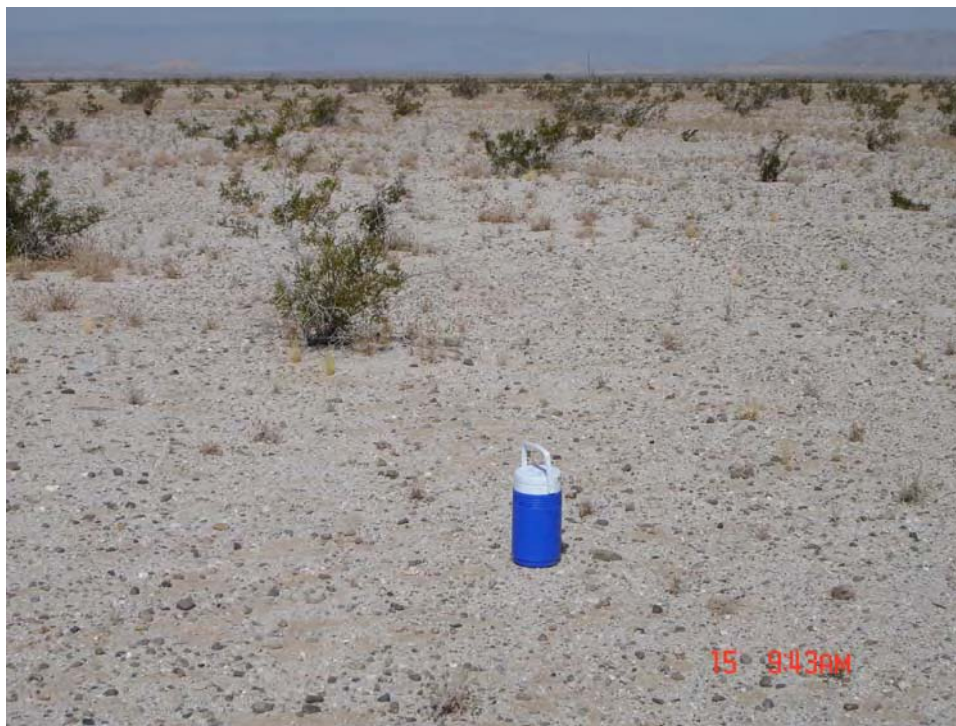
c. Loose gravel-sized material on the surface of the western portion of the OLS.

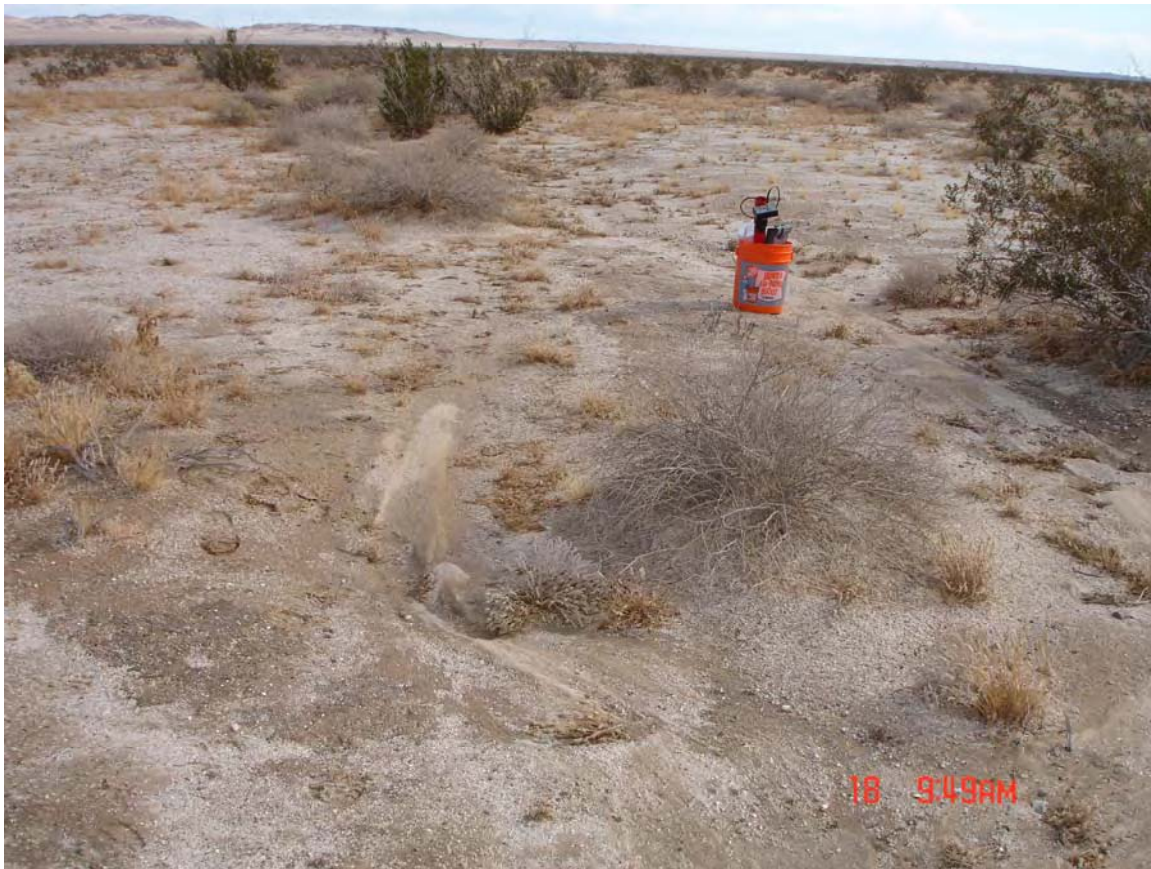
Figure 31. Surface run-off erosion and deposition features from the recent rain storm prior to IOP #2.

No surface water was observed on the RAS during any IOP. Puddles of water were observed on the low-lying areas outside of the RAS from a rain storm that occurred days before IOP #2. Erosion and deposition on the soil surface indicated that water flowed through the OLS during that rain event (Fig. 31).

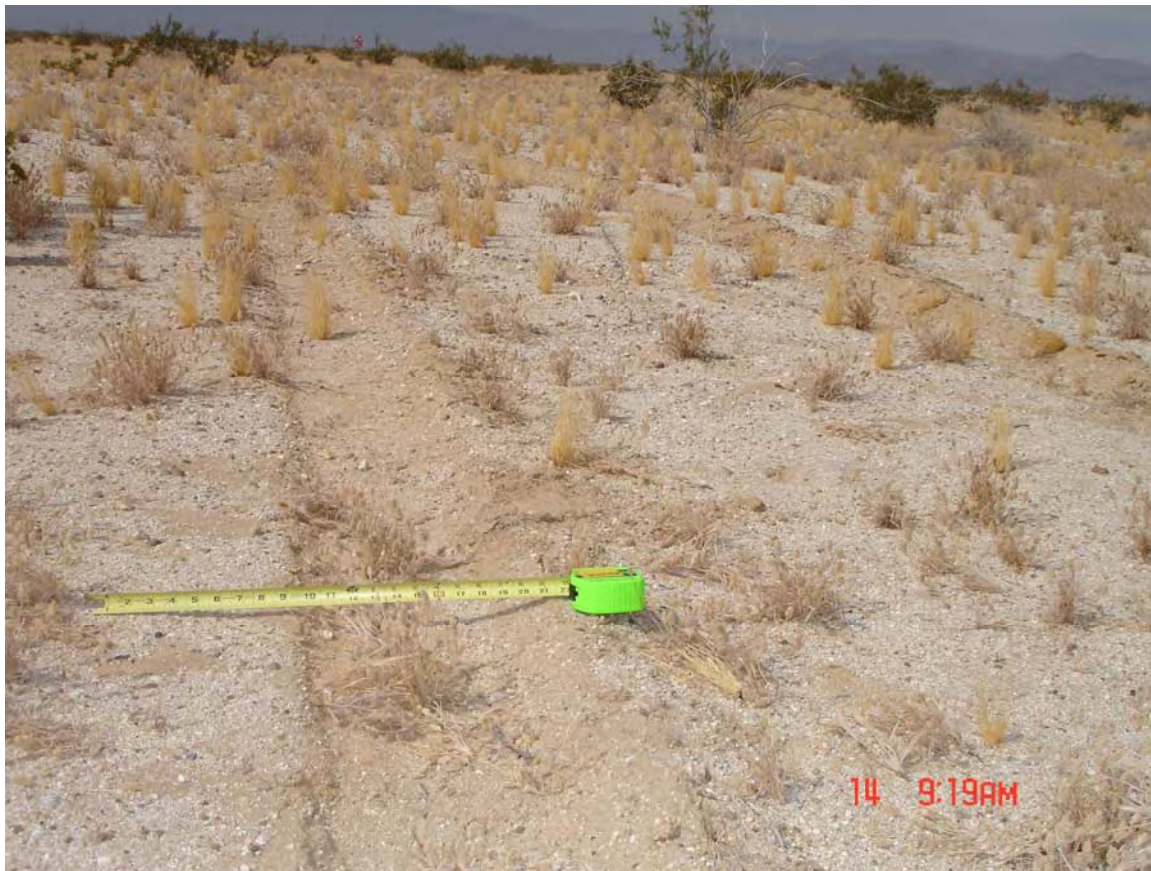
Figure 32. Existing ruts on the RAS from recreational vehicles.

Typical tracks found on the OLS were from four-wheeled and two-wheeled (dirt bike) vehicles. Tire tracks noted are sketched on Figure 25. Some tracks were as deep as 10 cm (4 in.) (Fig. 32).

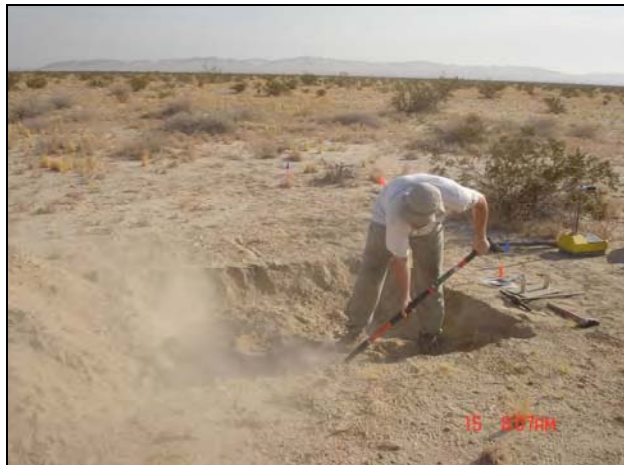
a. Dust generated during digging (IOP #1).

When the ground is disturbed, dust is quite common when fine particles become airborne, especially in the dry environment. At El Centro RAS, dust was observed while digging pits and backfilling (Fig. 33a) during IOP #1. Significant dust clouds occurred when driving vehicles (40 psi tire pressure) at speeds of 13.4–15.6 m/s (30–35 mph) on unpaved trails (Fig. 33b). The vehicle was barely visible by the observer and this was of course depending on the condition of the road such as areas of sand pockets and wind. But within 30 s after vehicles passed, dust clouds dissipated as a result of slight winds (Fig. 33c), giving clear visibility of the road from approximately 200 m (650 ft). During IOP #2, no dust was observed because rain storms occurred prior to the field visit.

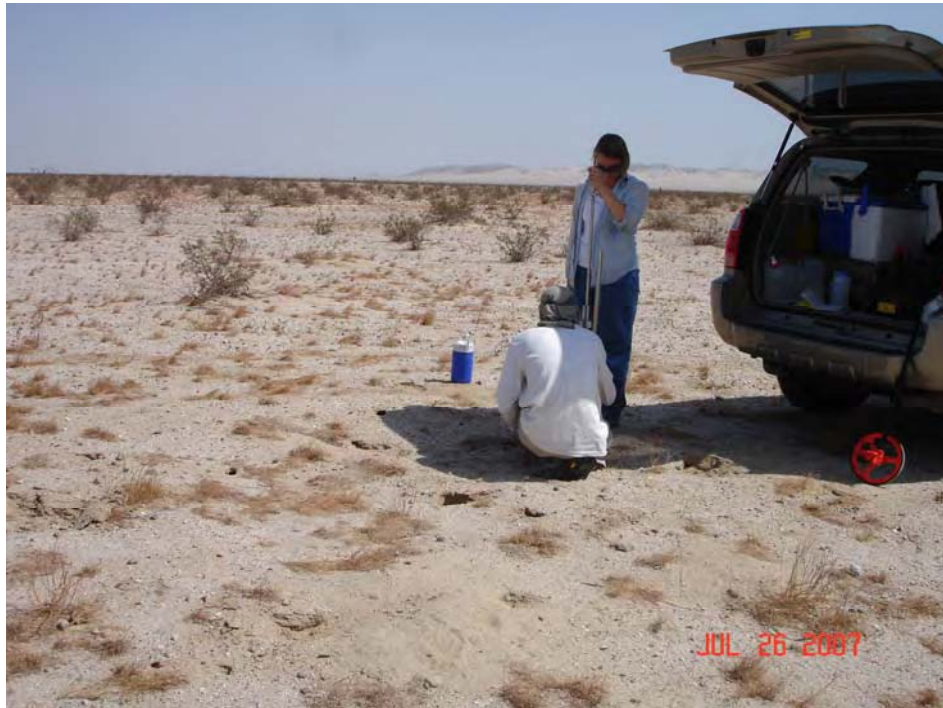
a. Looking north at 600 m west of the east end point of the PCI-RAS. DCP was conducted in the middle of the mounded area with animal hole.

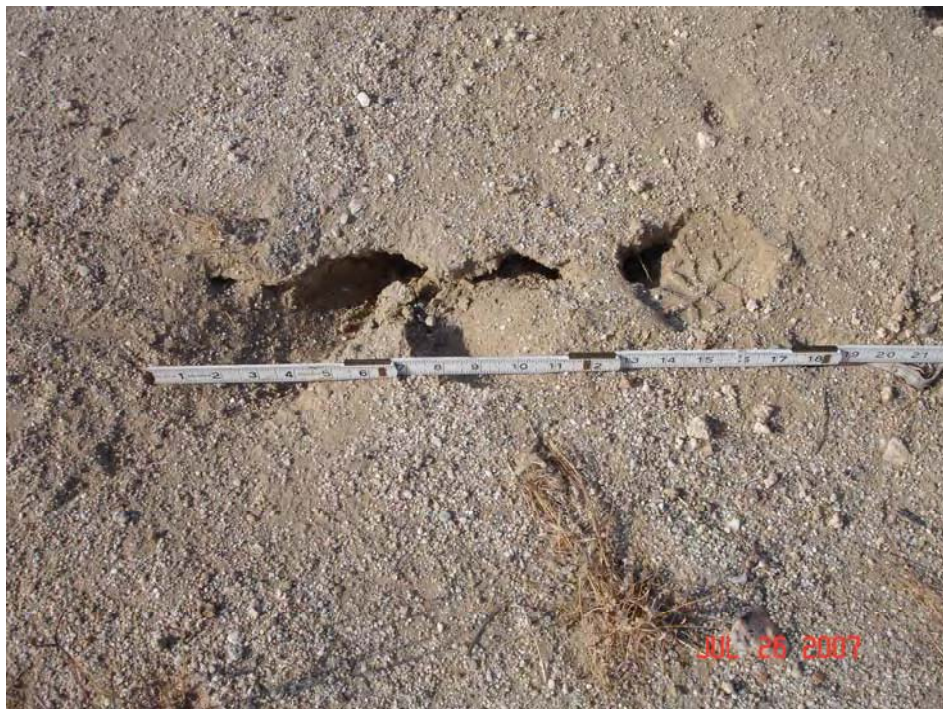
b. One of several animal holes observed on the PCI-RAS, showing a depression after a footstep.

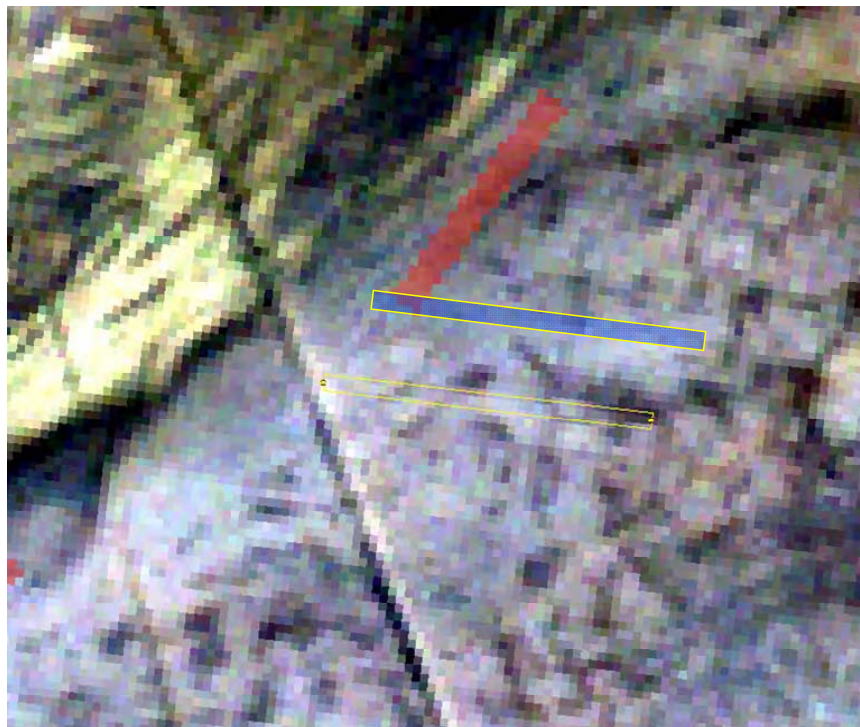
Figure 65. 1 November 2005 Landsat USGS Precision georeferenced image with Version 10 of the OLS software. Blue and red OLSs are in Precision georeferenced positions. The unfilled yellow outline OLS is the RAS field site from the Systematic georeferenced 9 May 2005 image. Filled yellow outline OLS is the field site as it should have been located from the Precision georeferenced 9 May 2005 image.

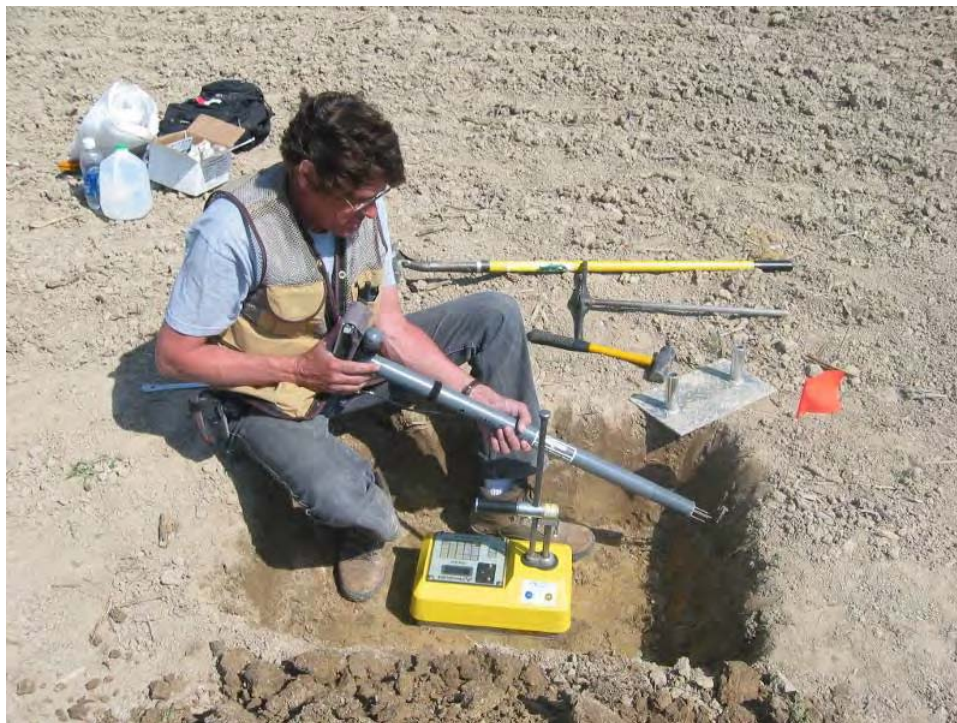
Figure C-4. Troxler nuclear gauge (yellow instrument) in moisture-reading configuration at the base of the soil pit. The Dynamax ML2 is held ready for measurement of soil moisture content, with the four stainless steel measuring rods visible at the right pit wall.
